NATIONAL TRANSPORTATION SAFETY BOARD
Vehicle Recorder Division
Washington, DC 20594

Onboard Image Recorder and Audio Transcript

Specialist's Factual Report
By Sean Payne

Location: Williams, AZ
Date: April 15, 2021
Aircraft: Cessna 140, N2506N
Operator: Private
NTSB Number: WPR21LA166

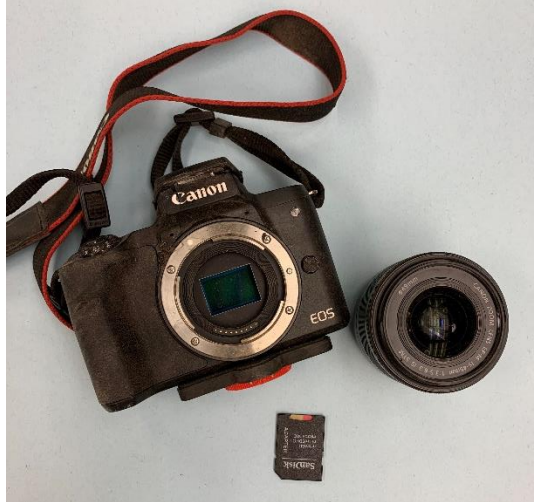
The camera sustained impact damage. The lens and the unit's internally mounted flash were displaced. The camera's condition is shown in figure 1. The memory card was undamaged, also shown in figure 1.

Figure 1. The Canon EOS M50, as received.

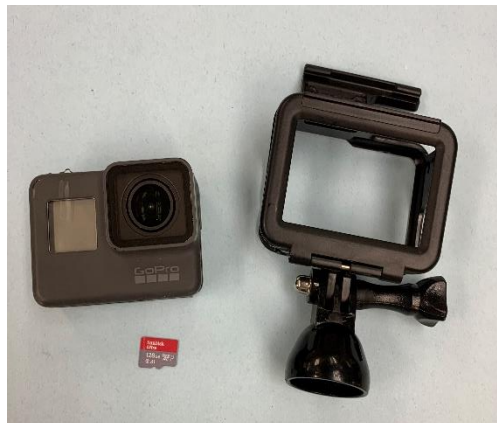
This camera was labeled as having been found in the cockpit. The camera sustained minor impact damage but was largely intact. The camera's microSD card was in good condition and was able to be read with a PC. The device and associated microSD card are shown in figure 2.

Figure 2. The GoPro recovered from the aircraft's cockpit.

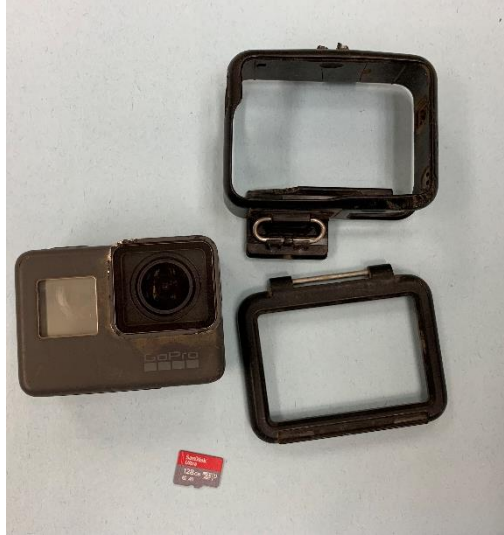
This camera was labeled as having been found in the vicinity of the left wing. The camera sustained minor impact damage but was largely intact. The camera's microSD card was in good condition and was able to be read with a PC. The camera's mounting device was broken. The device and associated microSD card are shown in figure 3.

Figure 3. The GoPro recovered from the aircraft's left wing.

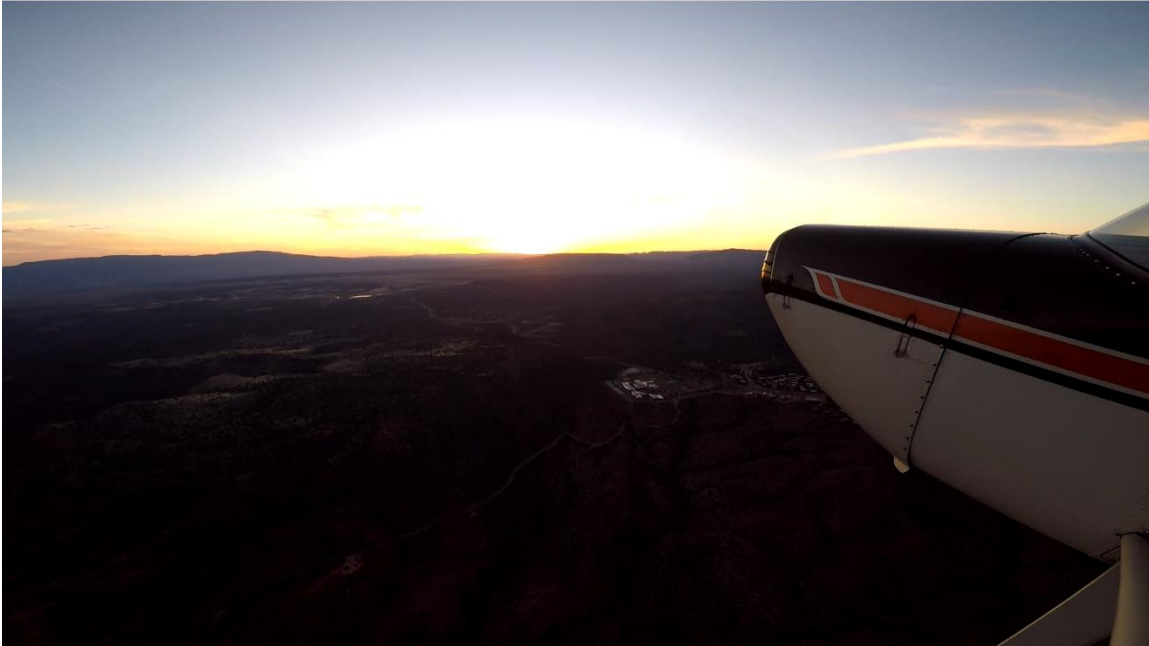
The recording captured the aircraft's start, run up, and departure from a location consistent with KSEZ. Figure 4 is a screen capture illustrating the field of view provided by the wing mounted camera.

Figure 4. A screen capture showing the field of view of the wing mounted camera just after departure from a location consistent with KSEZ.

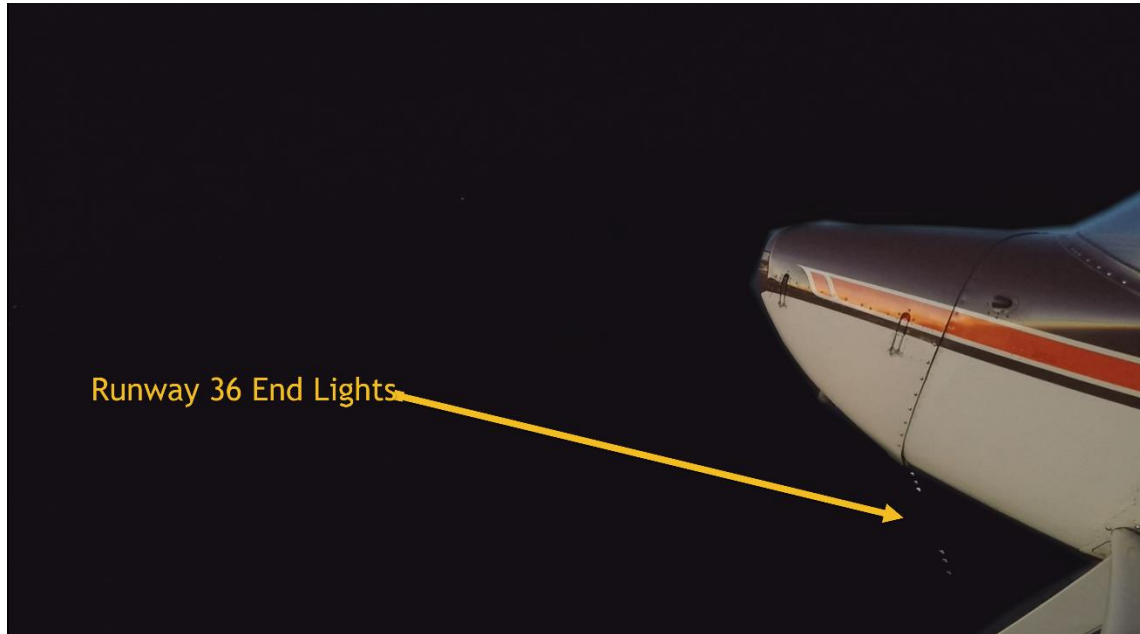
At 19:48:24, the aircraft began a right turn near the end of the runway. Runway end lights were visible below the aircraft, the altitude did not appear to significantly change. Figure 5 is a screen capture taken at 19:48:25 and illustrates the position of the aircraft in relation to the departure runway and the aircraft's attitude at this

Figure 5. A screen capture taken at 19:48:24 and is entered to illustrate the position of the aircraft in relation to the departure runway as well as reference to the aircraft's attitude state at this time. NOTE: An overlay mask of the aircraft's fuselage in illuminated conditions has been added to this screen capture to help illustrate the position of the aircraft relative to the ground lighting.

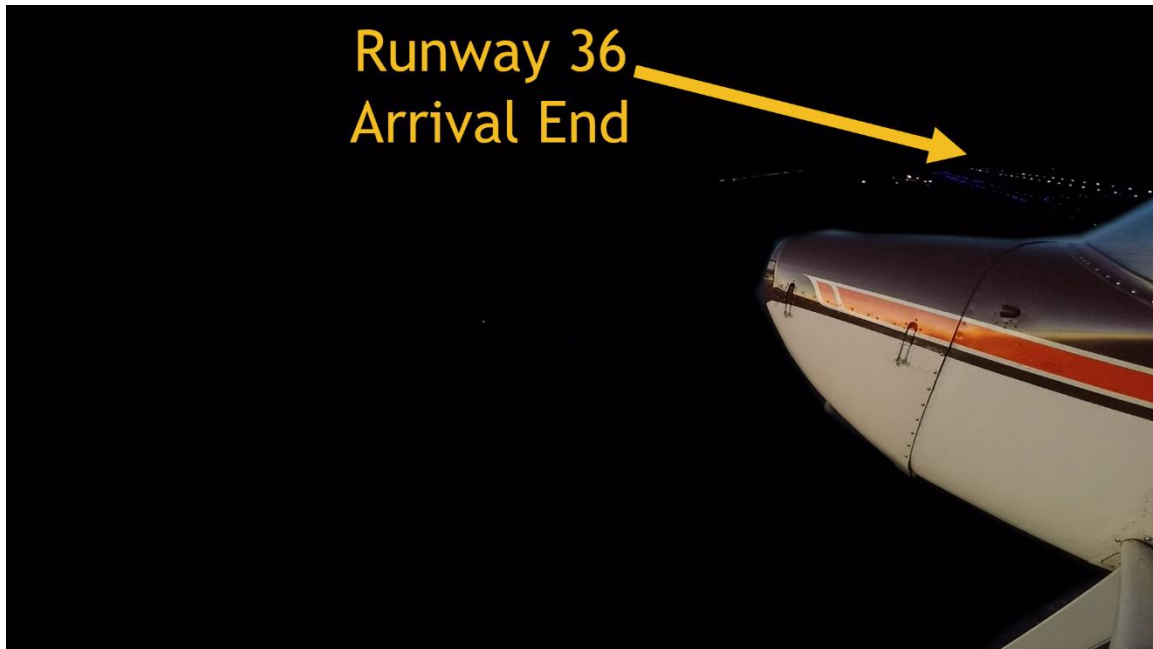
Around 19:48:31, a sound consistent with the engine power being reduced was noted. The aircraft's wings wobbled gently. The aircraft continued in a gentle right turn through 19:48:35. Figure 6 is a screen capture of the aircraft at 19:48:35. The figure shows the runway lighting in the distance to the right of the aircraft which demonstrates the heading change of the aircraft after departure.

Figure 6. A screen capture taken at 19:48:35 which shows the aircraft's position in relation to the runway as well as the heading change of the aircraft after departure. NOTE: An overlay mask of the aircraft's fuselage in illuminated conditions has been added to this screen capture to help illustrate the position of the aircraft relative to the ground lighting.

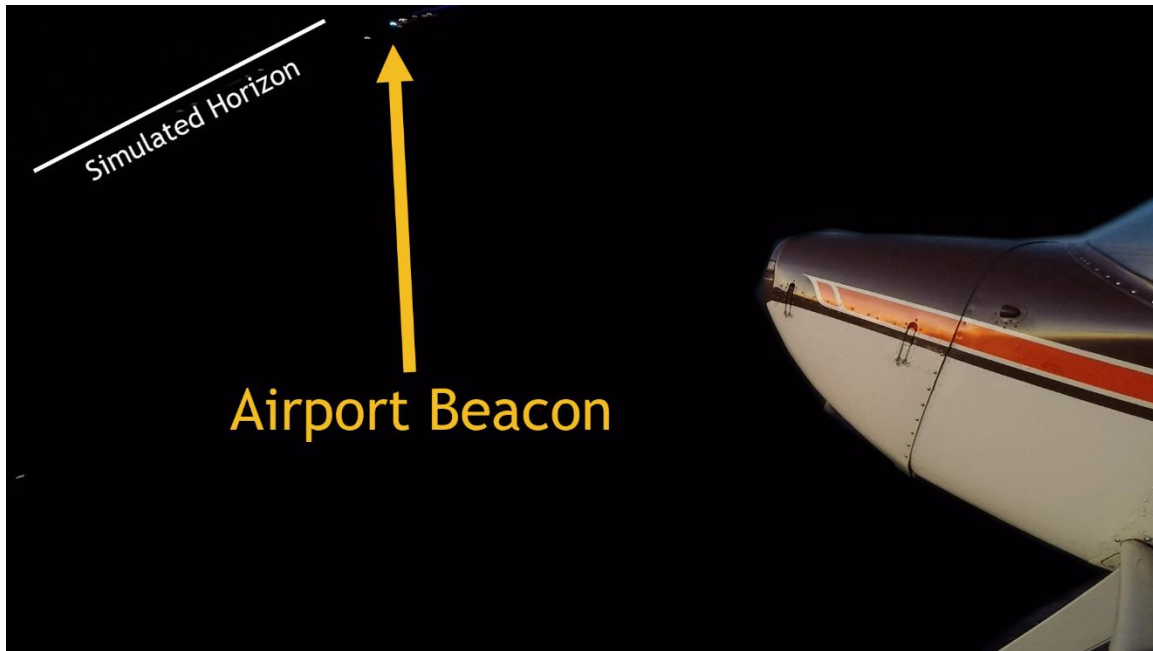
From 19:48:35 onward, the aircraft entered a steepening right bank. The right bank was not consistent with the aircraft entering a spin. Figure 7 is a screen capture taken at 19:48:39. The figure has been annotated to show the airport beacon as well as a simulated horizon line based on available lighted visual references. The figure illustrates the nature of the aircraft's right bank at this time.

Figure 7. A screen capture taken at 19:48:39 which shows the aircraft's position in relation to the runway, airport beacon as well as the heading change and roll condition of the aircraft after departure. NOTE: An overlay mask of the aircraft's fuselage in illuminated conditions has been added to this screen capture to help illustrate the position of the aircraft relative to the ground lighting.

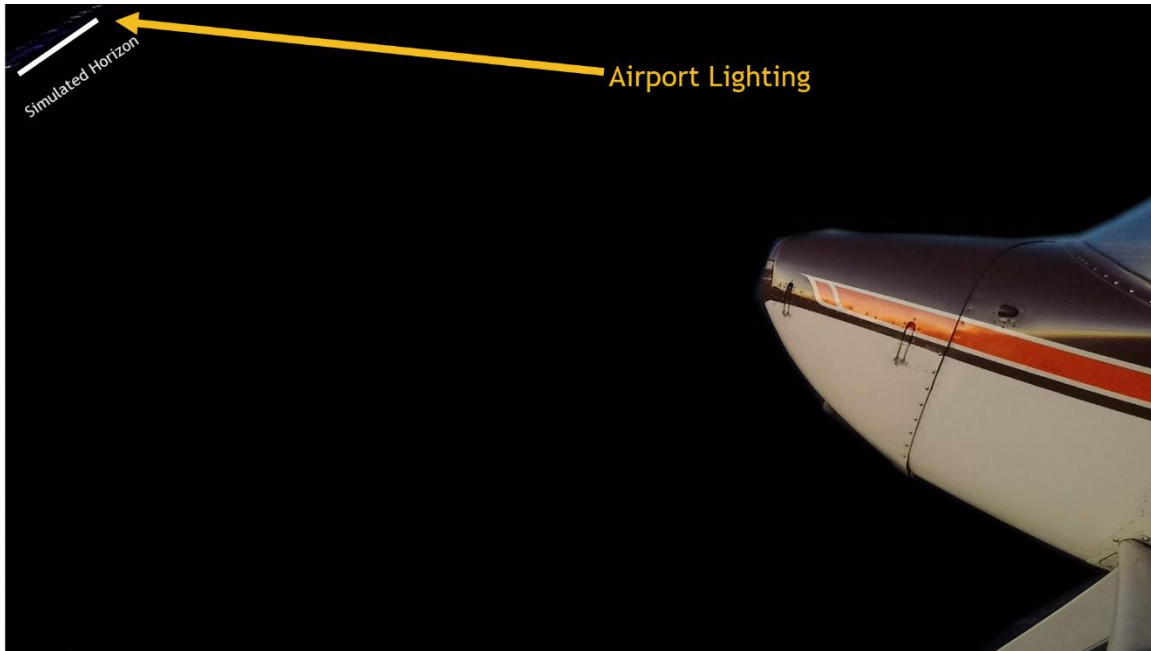
One second later, the rate of heading change increased to the right. The aircraft appeared to roll more aggressively right, but was not consistent with a spin entry. Figure 8 is a screen capture taken at 19:48:40. The screen capture has been annotated to show the direction to the airport beacon (not visible) as well as a simulated horizon line based on available lighted visual references. This is to illustrate the position of the aircraft in relation to the departure runway, as well as the bank angle.

Figure 8. A screen capture taken at 19:48:40 illustrating the aircraft's position in relation to the departure runway as well as the aircraft's bank angle. NOTE: An overlay mask of the aircraft's fuselage in illuminated conditions has been added to this screen capture to help illustrate the position of the aircraft relative to the ground lighting.
